# Manhole Inspection Summary

Manhole # S31GG\_005MH

Insp Date: **1/19/07 12:12 PM**

**Location** Address: **121 LANVALE ST**

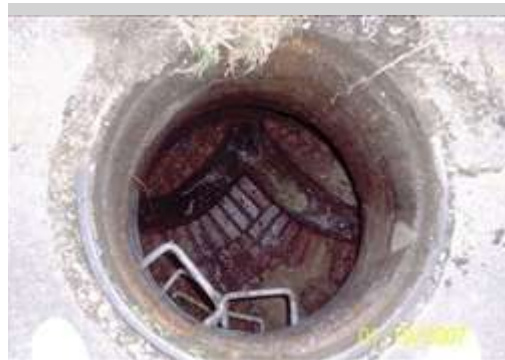
Top View

Evidence of surcharge - Bench debris.  
Channel debris.

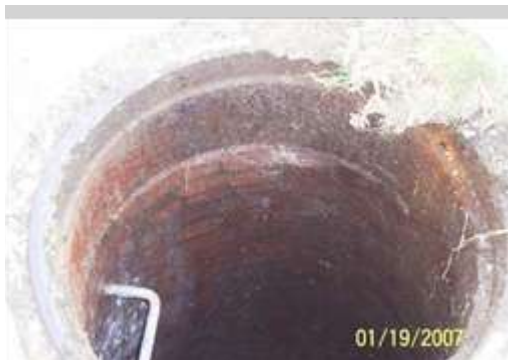
Defect

Frame leaks. Adjustment root intrusion  
and infiltration. Corbel and Barrel  
infiltration - other side.

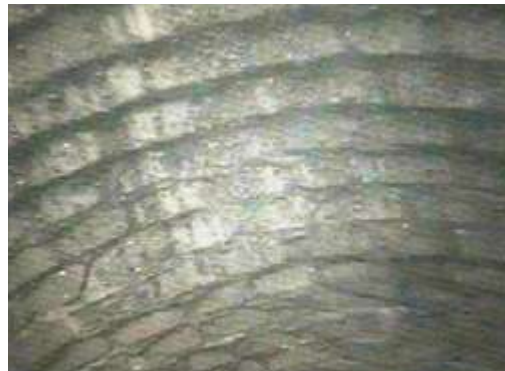
Defect

Barrel deterioration and infiltration.

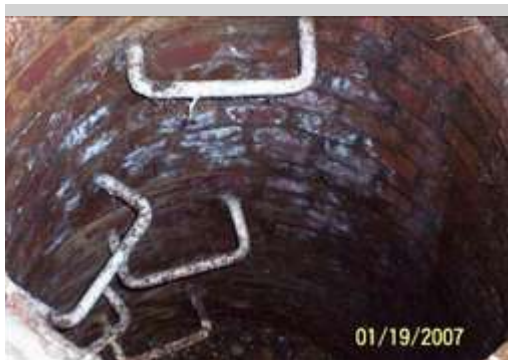
Defect

Adjustment root intrusion and infiltration.  
Corbel and Barrel infiltration.

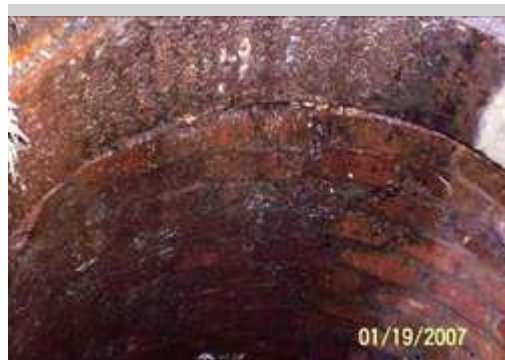
Defect

Frame leaks. Adjustment root intrusion  
and infiltration.

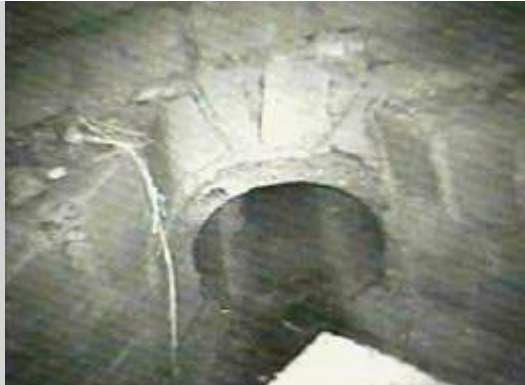
### 8 in. Circular Gravity Sewer Pipe Out @ 12 O'Clock

Infiltration: **Evidence** Pipe Seal Cond: **Cracked**

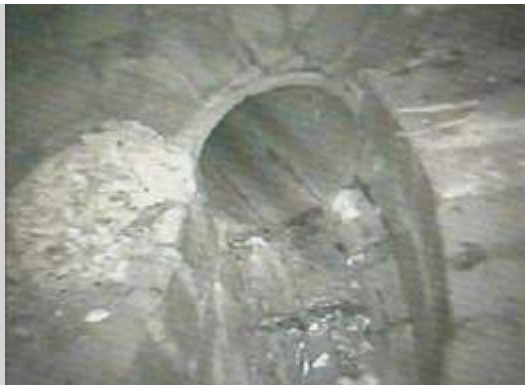
### 8 in. Circular Gravity Sewer Pipe In @ 3 O'Clock

Infiltration: **Evidence** Pipe Seal Cond: **Cracked**

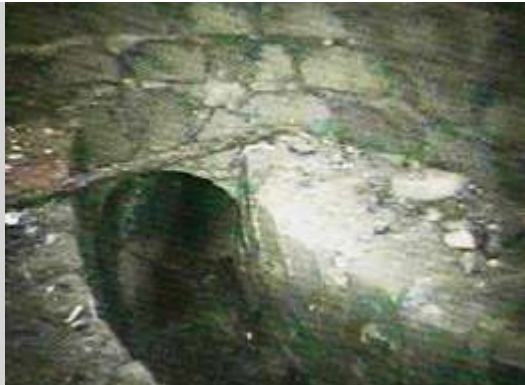
Pipe In @ 9 O'Clock

Barrel deterioration and infiltration.

Infiltration: **Evidence** Pipe Seal Cond: **Cracked**
